CERTIFICATE

(Certificate of conformity with technical requirements in:) API STANDARD 607 Eighth Edition, October 2022

(Valve Fire Test According to API STANDARD 607 Eighth Edition, October 2022.)

Certificate No.: 314445 Test Report No.: 314444

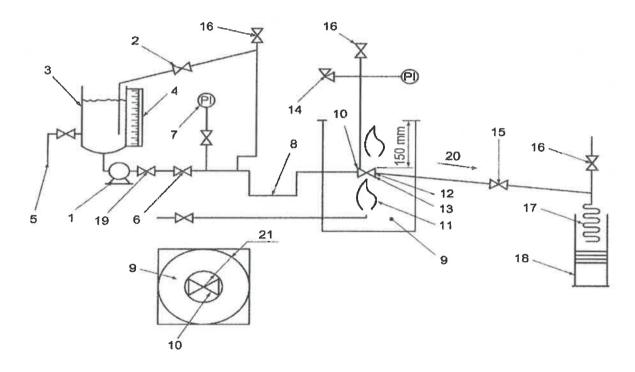
Figure 1. Typical Fire-Test System Using a Pump as the Pressure Source

The test equipment was verified by TÜV SÜD inspector according to requirements of API STANDARD607 Eighth Edition, October 2022. Para.5.3 and found satisfactory. The detail arrangement of the fire-test equipment is shown below:

Pressure source	10. Test valve mounted horizontally	Check valve
2. Pressure regulatorand relief	with stem in horizontal position	20. Slope
2 Massal for water	11 Fuel ace cupply and burner	24 Classenses d

3. Vessel for water 11. Fuel gas supply and burner 21. Clearance: 150mr	•	·	
	3. Vessel for water	11. Fuel gas supply and burner	21. Clearance: 150mm

J. VESSELIOI Water	i i. i dei gas supply allu bulllel	Z I. Cleara
4. Calibrated sight gauge	12. Calorimeter cubes	
5. Water supply	13. Flame environment and body the	rmocouples
6. Shutoff valve	14. Pressure gauge and relief valve

o. Onaton valve	14. I ressure gaage and relief valve
7. Pressure gauge	15. Shut-off valve
8. Piping arranged to	16. Vent valve
provide vapor trap	17 Condenser

9. Enclosure for test 18. Container

- 6. Preparation before testing:
- 6.1 The thermocouples and calorimeters were installed properly according to Figure 1,2,3,4 in API 607. Two thermocouples (part 13) are installed to measure flame temperature, one is located under valve body, another is located under valve stem, both within 1". Two calorimeters (part 12) are positioned to the same place as the thermocouples do.

- 6.2 The test system including test valve (part 10) was cleaned through by water before testing. All air was purged from test valve and testing system by water.
