# ISO 15848-1 QUALIFICATION **CERTIFICATE**

Certificate No.: 314532 Ref. Test report No.: 314531

# **Test Report**

(Valve fugitive emission test according to ISO15848-1: 2015+Amd.1:2017)

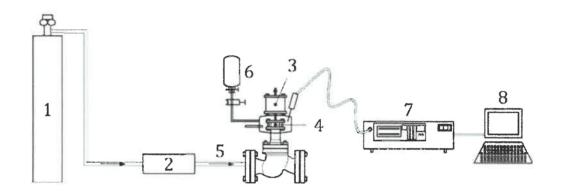
Figure 1 Typical stem seal leakage measurement system with Bagging Method

- 1 helium at 97 % purity
- 2 pressure control
- 3 actuator
- 4 sealed volume or bag

- 5 helium
- 6 standard calibrated leak
- 7 helium mass spectrometer
- 8 data acquisition

The stem seal leakage measurement was performed by the bagging method as described in ISO15848-1 Annex A.

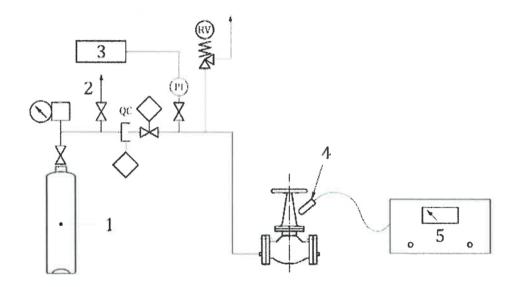
Figure 2 Typical body seal leakage measurement system with Sniffing Method

- 1 helium gas supply
- 2 vent
- 3 pressure recorder
- 4 probe

- 5 mass spectrometer
- QC quick coupling
- RV relief valve
- Pl pressure sensor

The body seal leakage measurement was performed by the sniffing method as described in ISO15848-1 Annex B.
